Manhole Inspection Summary

Manhole # S23K__018MH

Insp Date: **6/10/08 1:03 PM**

Location Address: **335 Parrish St**

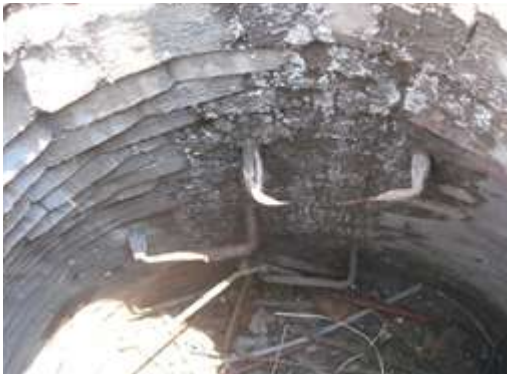
Defect 6

Count: **3** Missing: **0** ☒ **Corroded**

broken and oxidized rungs

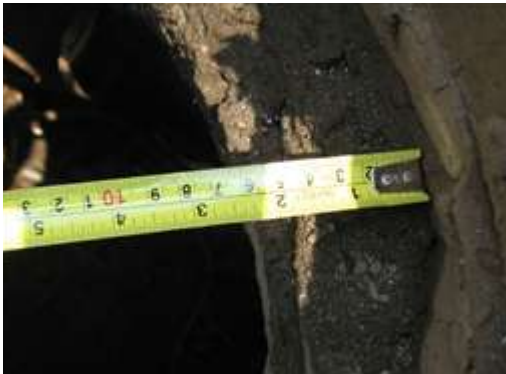
Defect 4

Offset: **2.5** (in.)

2.25 frame offset

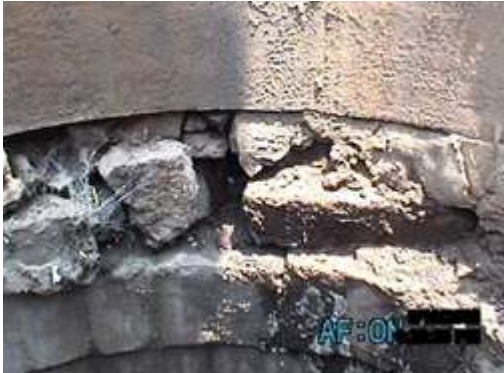
Defect 3

missing mortar ,loose bricks,
chimney-frame joint infiltration

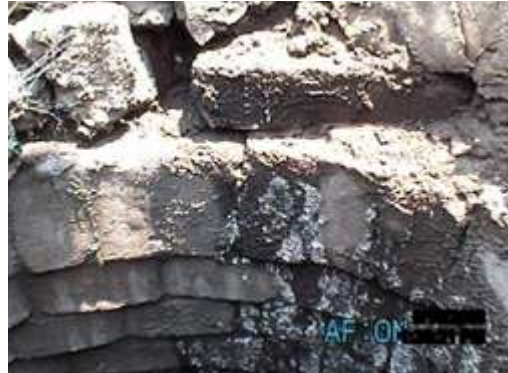
Defect 5

Condition: ☐ Sound ☐ Cracked ☐ Root Intrusion ☒ **Loose Brick** ☒ **Deteriorated**

Infiltration: ☐ None ☒ **Joint** ☐ Cracks ☒ **Mortar** ☐ Roots ☒ **Wall**

loose bricks, missing mortar, deteriorated
chimney ,infiltration chimney-frame joint

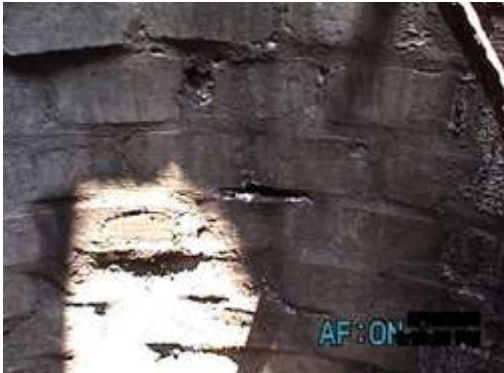
Defect 2

Infiltration: ☐ None ☐ Joint ☐ Cracks ☐ Mortar ☐ Roots ☒ **Wall**

infiltration barrel

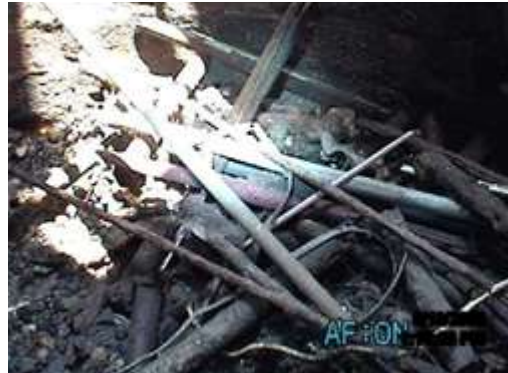
Defect 1

Condition: ☐ Sound ☐ Cracked ☐ Root Intrusion ☐ Deteriorated ☐ Leaks ☒ **Debris**

debris bench as well as channel
